# Part C:

## Seniors Resource and Recreation Centre

**CITY OF LANGLEY**  
Pond Management Strategies

**Seniors Centre Pond**  
**Key Issues**  
Figure 14

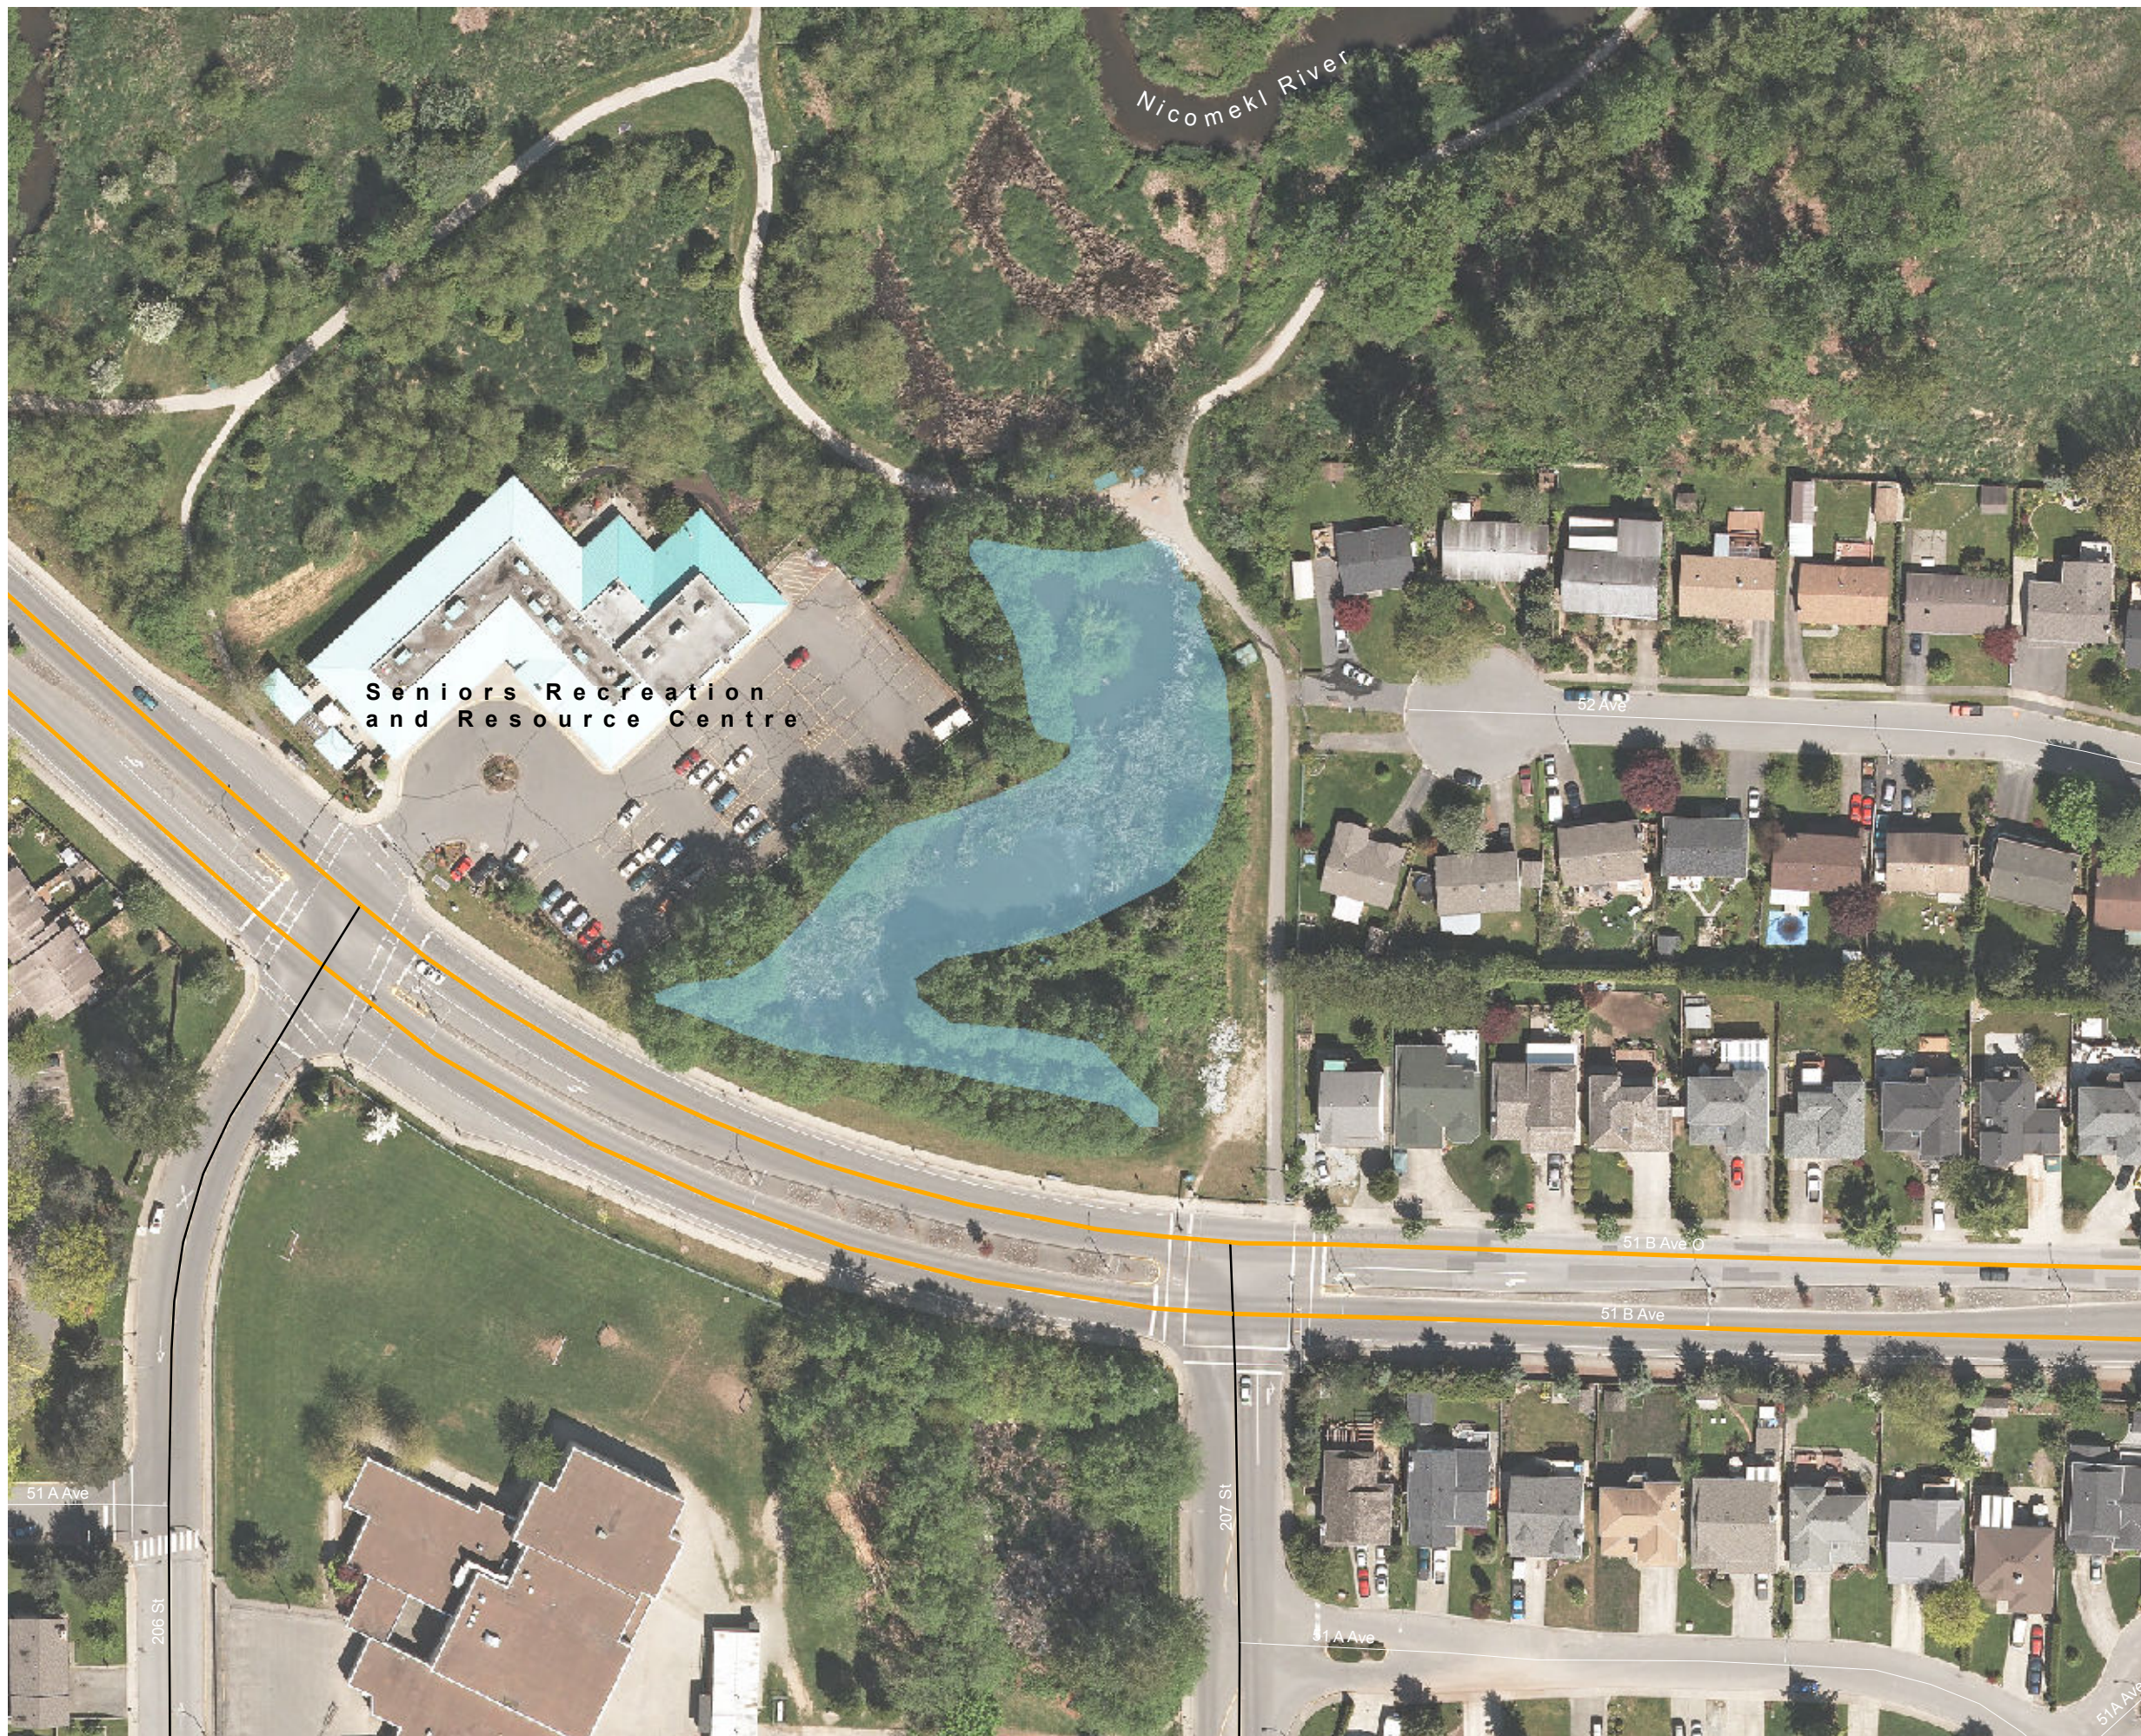
The local context of the Seniors Centre Pond is shown on Figure 9 on the following page.

**Seniors Recreation and Resource Centre Pond Location Plan**

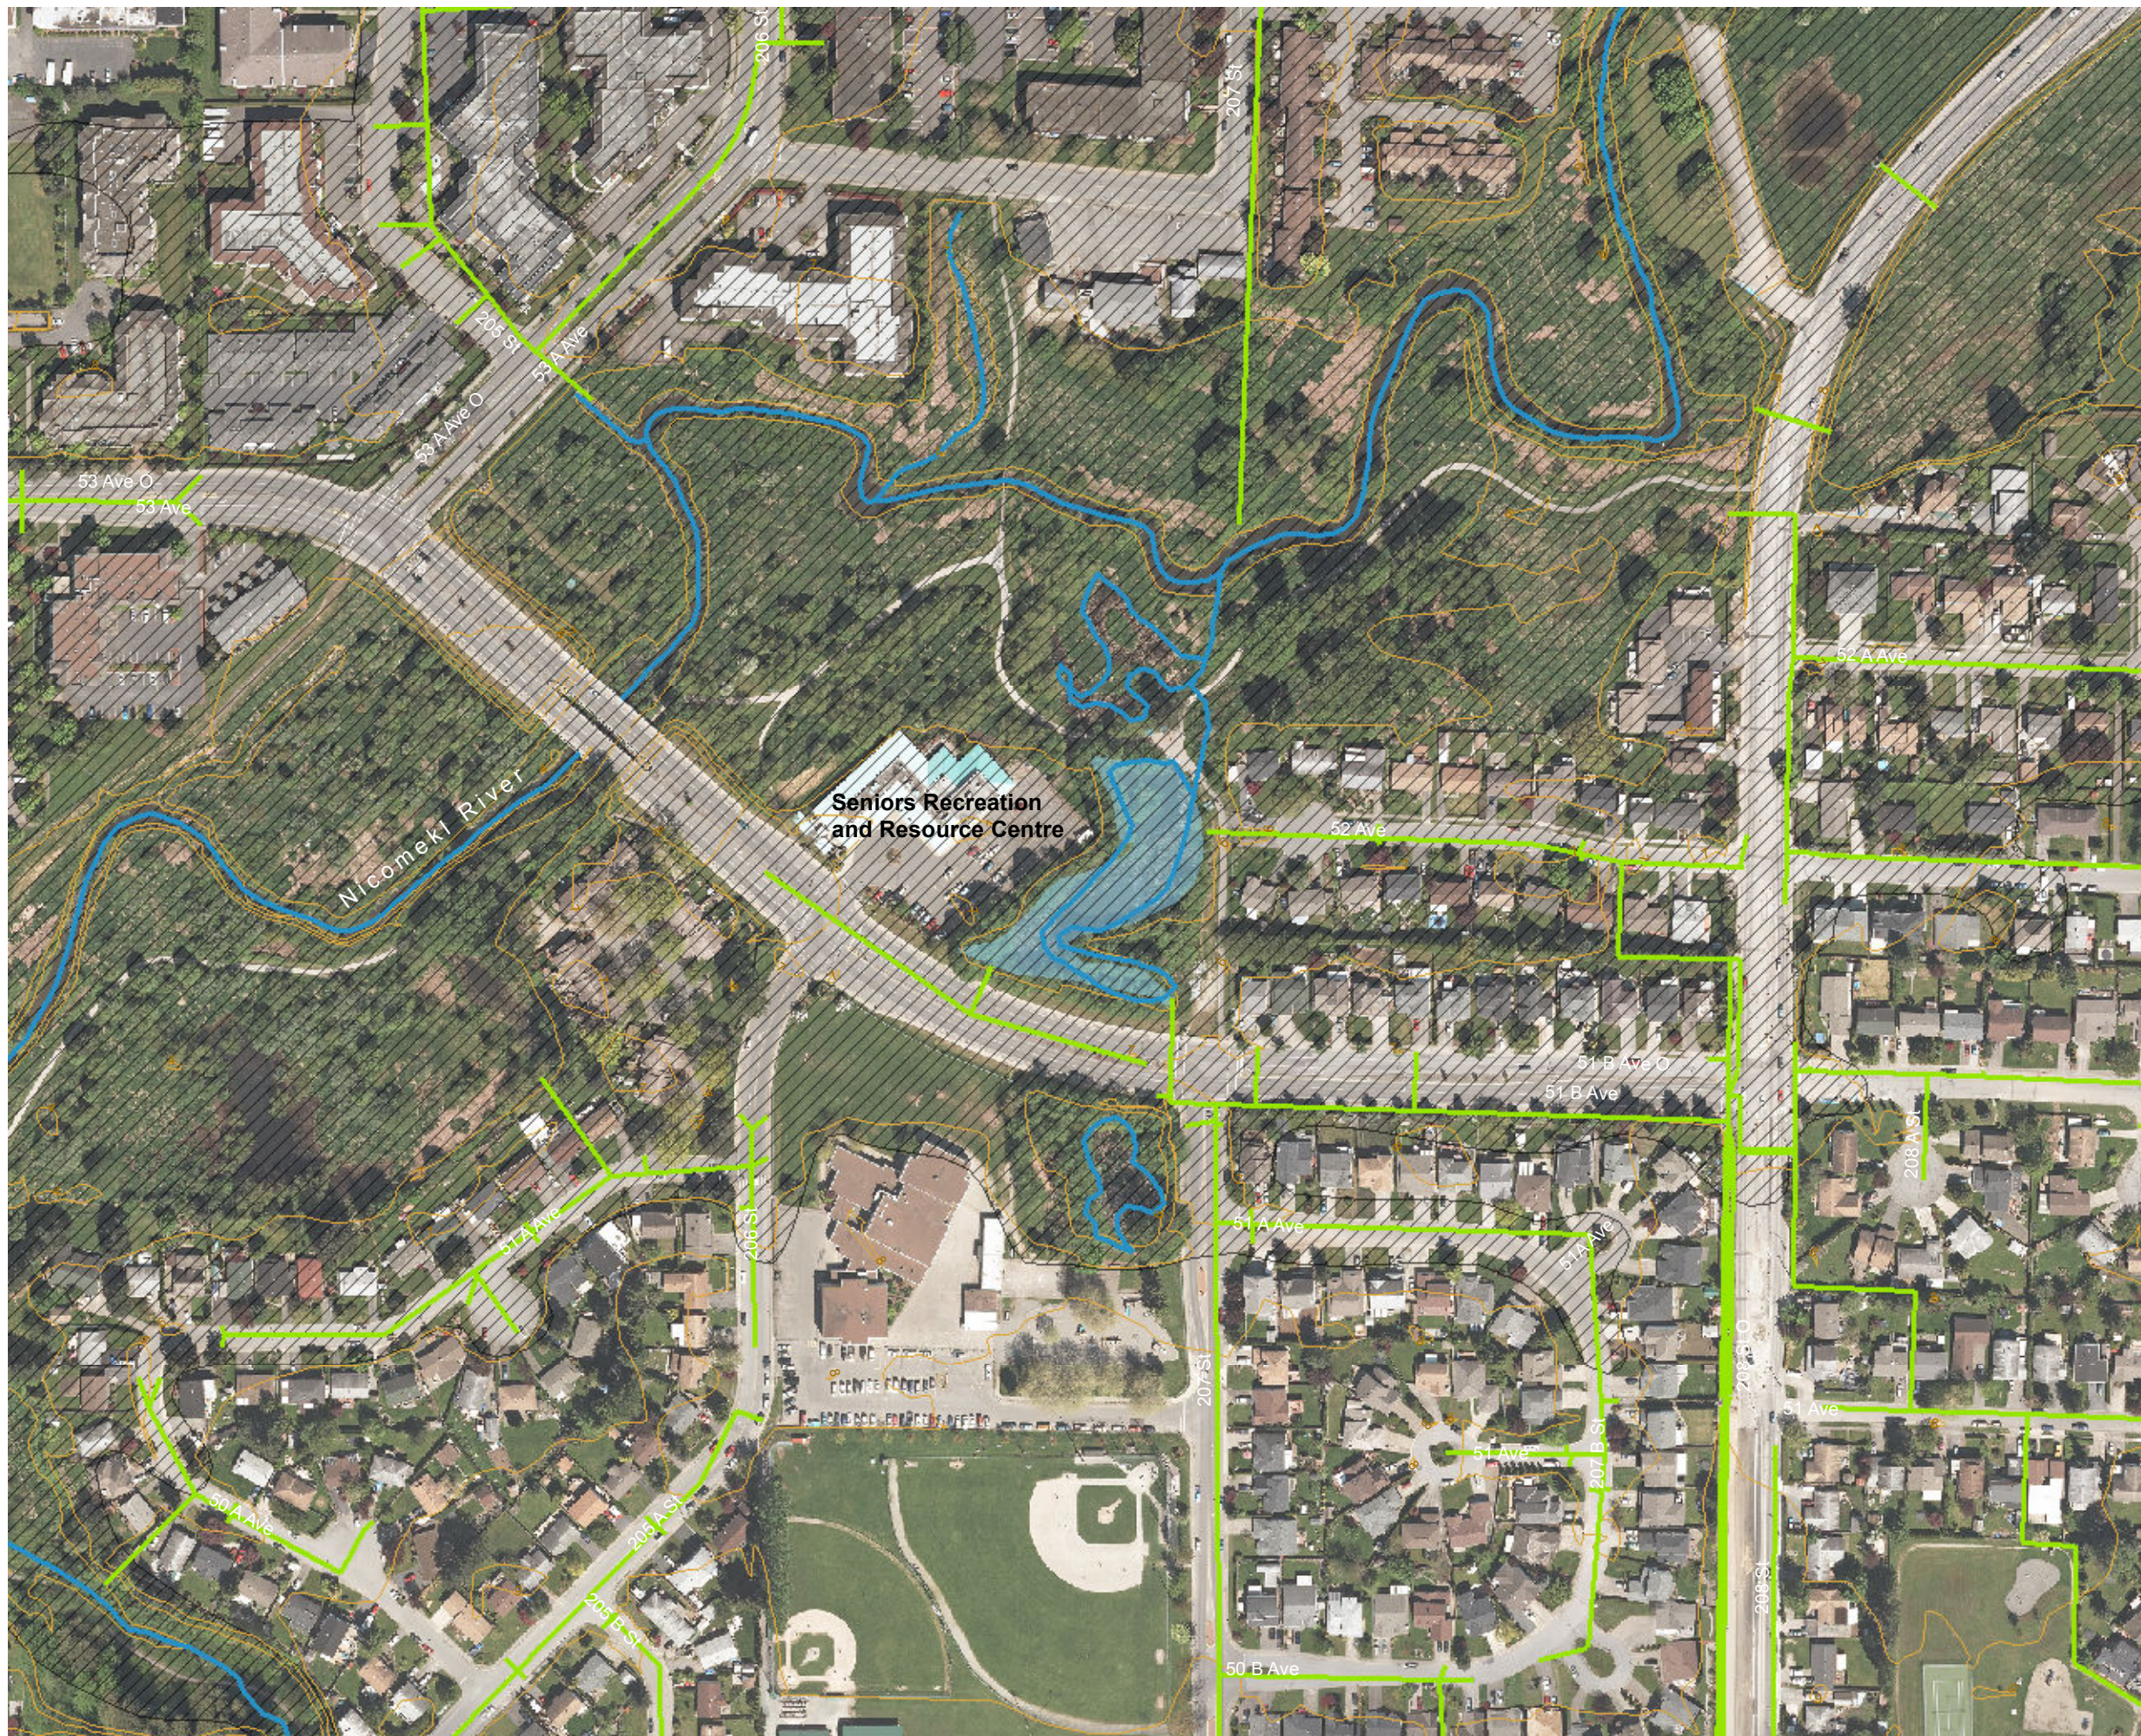
**Seniors Recreation and Resource Centre Pond Existing Drainage Features**  
Figure 10

The pond is an irregular shaped stormwater management facility located in the Nicomekl floodplain east of the Seniors Resource Centre (refer to Figure 10). It is surrounded by vegetation on all sides and bound to the north and east by an asphalt pathway that forms a portion of the Nicomekl trail system, to the south by 51B Avenue, and to the west by the Seniors Resource Centre parking lot.

Based on the City's storm sewer system mapping, there are three outfalls that discharge flows into the pond, which are located along its southern and eastern banks. The pond has a single outlet pipe located along its northern perimeter that conveys outflows beneath an asphalt pathway that discharges into a short segment of drainage channel that directs flows to a second culvert under a separate section of the Nicomekl trail network, which discharges into a channel that flows into the Nicomekl River.

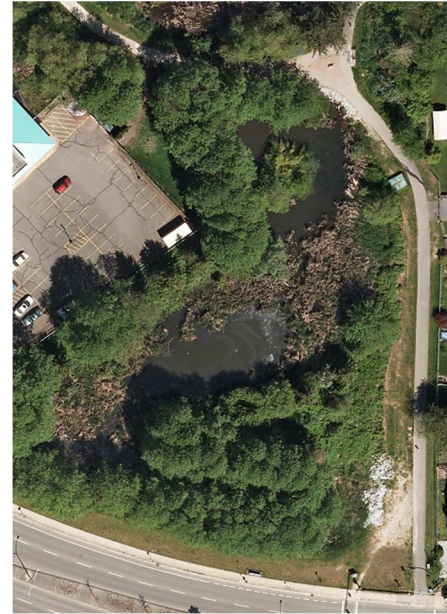
As shown on the adjacent aerial photograph of the site, much of the pond is overgrown with cattails, reeds, and other vegetation.

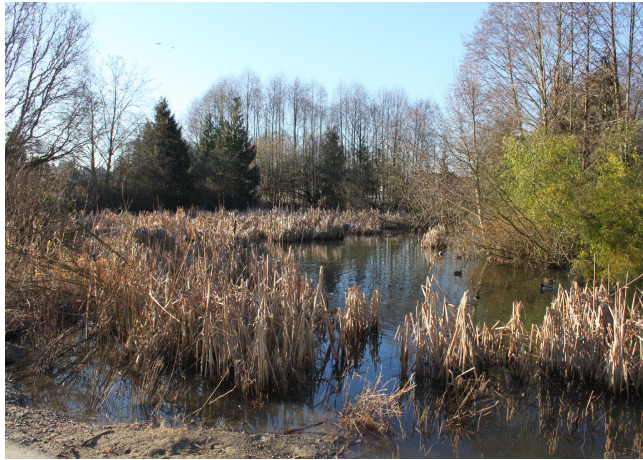
1 Overgrown Aquatic Vegetation

- iii) Portions of the pond are overgrown with vegetation (*i.e.*, cattails, reeds, etc.), which impacts the hydraulic performance and reduces the available volume within the pond through accumulation at the base and fringes of the facility.
- iv) Fluctuating water levels have resulted in considerable deterioration of paved pathway along northern limits of pond – efforts to remediate through the placement of rip-rap have been moderately successful, however, a long-term solution to address this issue is required.
- v) The existing culvert is typically submerged and clogged with vegetation, sediment, and other debris. Furthermore, the configuration and condition of the culvert does not facilitate the passage of fish in and out of the pond with ease.

It is recommended that accumulated sediment and some of the existing aquatic vegetation (i.e., cattails, reeds, etc.) are removed from the pond to improve its hydraulic performance. Based on the results of field investigations, the clean-out efforts should focus on the following portions of the pond:

The most effective and practical method of removing the accumulated materials would likely involve the use of a long-reach excavator, which could access the pond by using mud mats or a suitable alternative to provide a sufficient working area. It is recommended that the handling, storage, and transportation of the excavated material should be undertaken in accordance with best practices for sediment control to minimize potential impacts to receiving watercourses. The estimated costs included in Table 11 are based on the understanding that the accumulated materials are not contaminated, in accordance with applicable standards prescribed by the *Contaminated Sites Regulation (BC Reg. 97/2011)*.

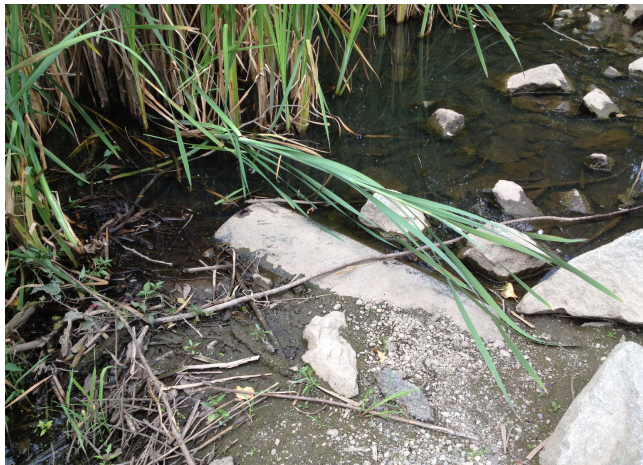
3 Pond Outlet Culvert to Nicomekl River

Further to the above, the existing HDPE culvert structure that conveys pond outflows to the receiving drainage system is undersized and currently clogged with a considerable amount of sediment and debris. It is proposed that the structure is replaced with a new culvert complete with headwalls at the inlet/outlet. Although the size and configuration will depend largely on the existing physical constraints (i.e., pathway elevation, grading, etc.), it is recommended that the new culvert is at least a 900 mm diameter structure – similar to the recently replaced culvert at the downstream crossing of the Nicomekl River trail.

2. Improve Hydraulic Performance	- Replace existing HDPE pond outlet culvert.	Short-term	Engineering	Requirement	Functional engineering design	LS	1	\$25,000	\$25,000	\$8,750	\$33,750	\$250	Based on 900 mm diameter CSP (similar to downstream culvert replacement). O&M costs for annual inspection, debris removal and flushing.

Consideration could also be given to moving the outlet structure closer to the northwest corner of the pond, which would provide a direct hydraulic connection to the north side of the Nicomekl trail and reduce flows contributing to the downstream culvert noted above.

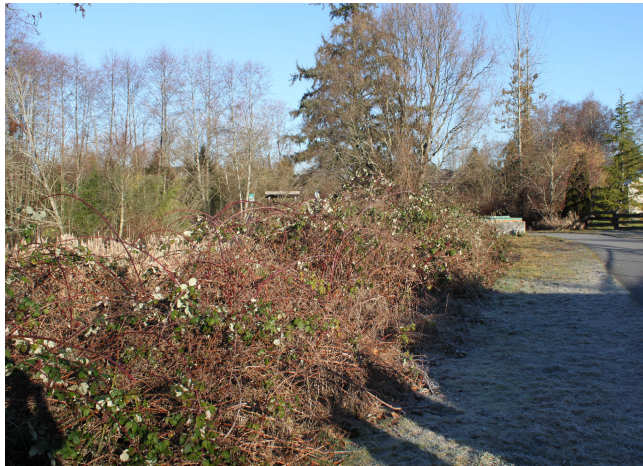
5 Invasive Vegetation Around Pond Perimeter

The vegetation within the project area composes a plant community of limited complexity, with relatively low species diversity and dominance of only a few species. The area has a high preponderance of Himalayan blackberry, an aggressive species that is able to spread quickly, resulting in its establishment and a related reduction in the growth of other species. Aquatic vegetation observed included reed canary grass. The other invasive plant species was English holly.

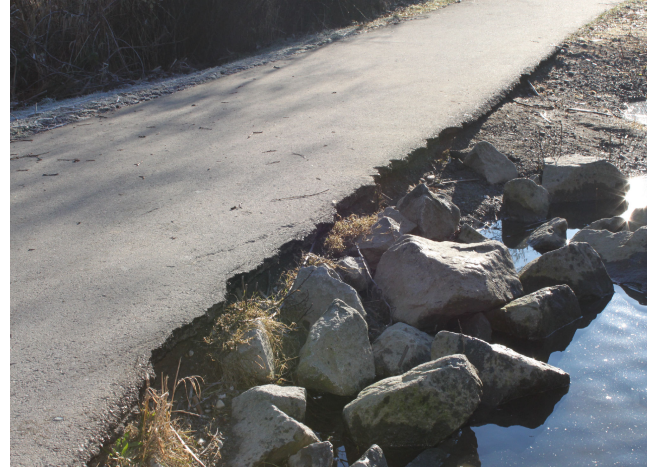
2 Erosion and Asphalt Eroding Along Pathway

The existing asphalt pathway along the northern edge of the pond has experienced considerable deterioration as a result of fluctuations in the water level of the pond as well as periodic overtopping during significant flow events. Previous efforts to address this issue through the placement of rip-rap stone along the pond edge have not resolved the problem.

It is proposed that the southern bank of the pond is stabilized through a combination of bio-engineering techniques and armouring. This could include the addition of suitable materials that would create a physical separation/barrier between the pond edge and the pathway, such as a vegetated buffer that is reinforced with large stones. In addition to remediating the ongoing asphalt deterioration, these efforts would also provide an increased level of safety for pathway users.

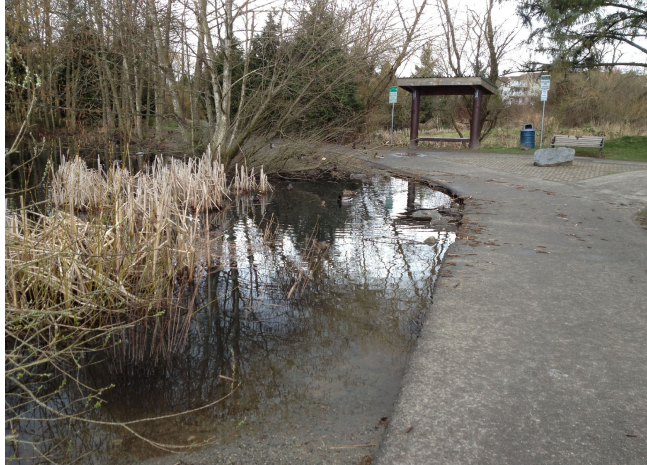
4 High Water Level in Pond

Water levels in the pond fluctuate depending on the magnitude of inflows, together with available storage volume and the associated outlet conditions (*i.e.*, blockages, tailwater conditions, etc.). During wet weather conditions, the pond level increases as inflows exceed the capacity of the outlet culvert. When the available storage volume is exceeded, water levels have been observed to overtop the pathway along the north edge of the pond and flow overland into the Nicomekl River.

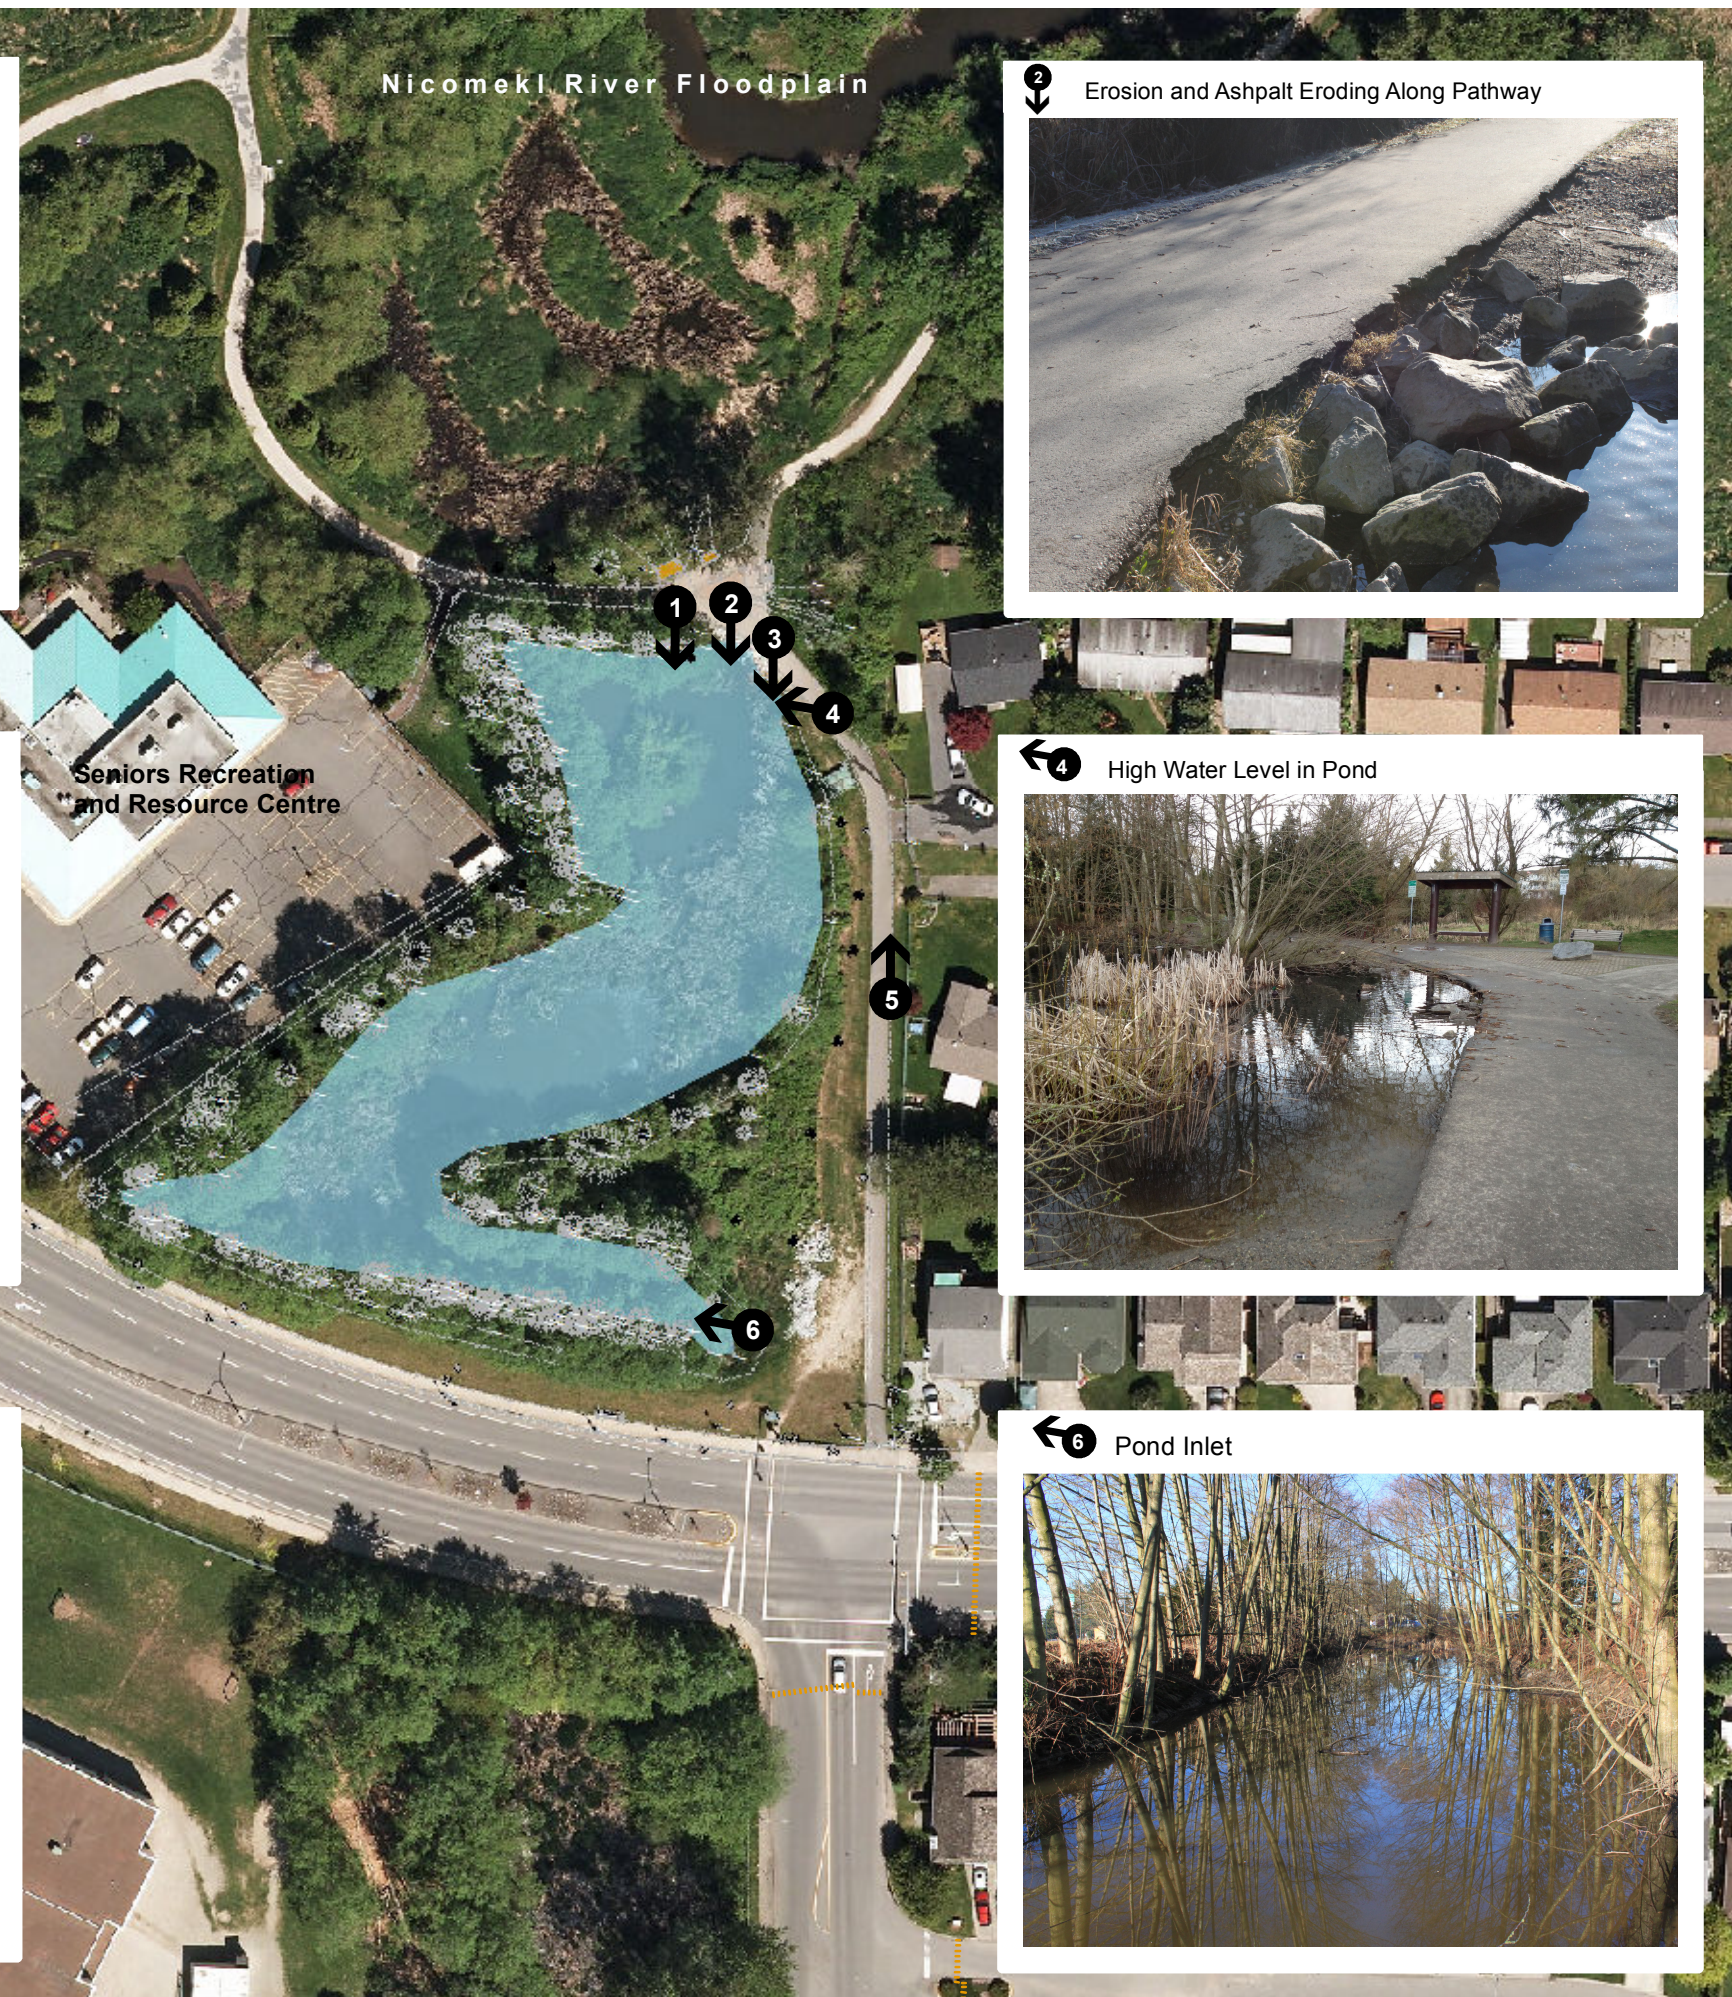
During the Functional Evaluation a number of key issues were identified, which are summarized in this section. Issues that can be represented spatially are shown on Figure 14 on the following page, with corresponding photographs.

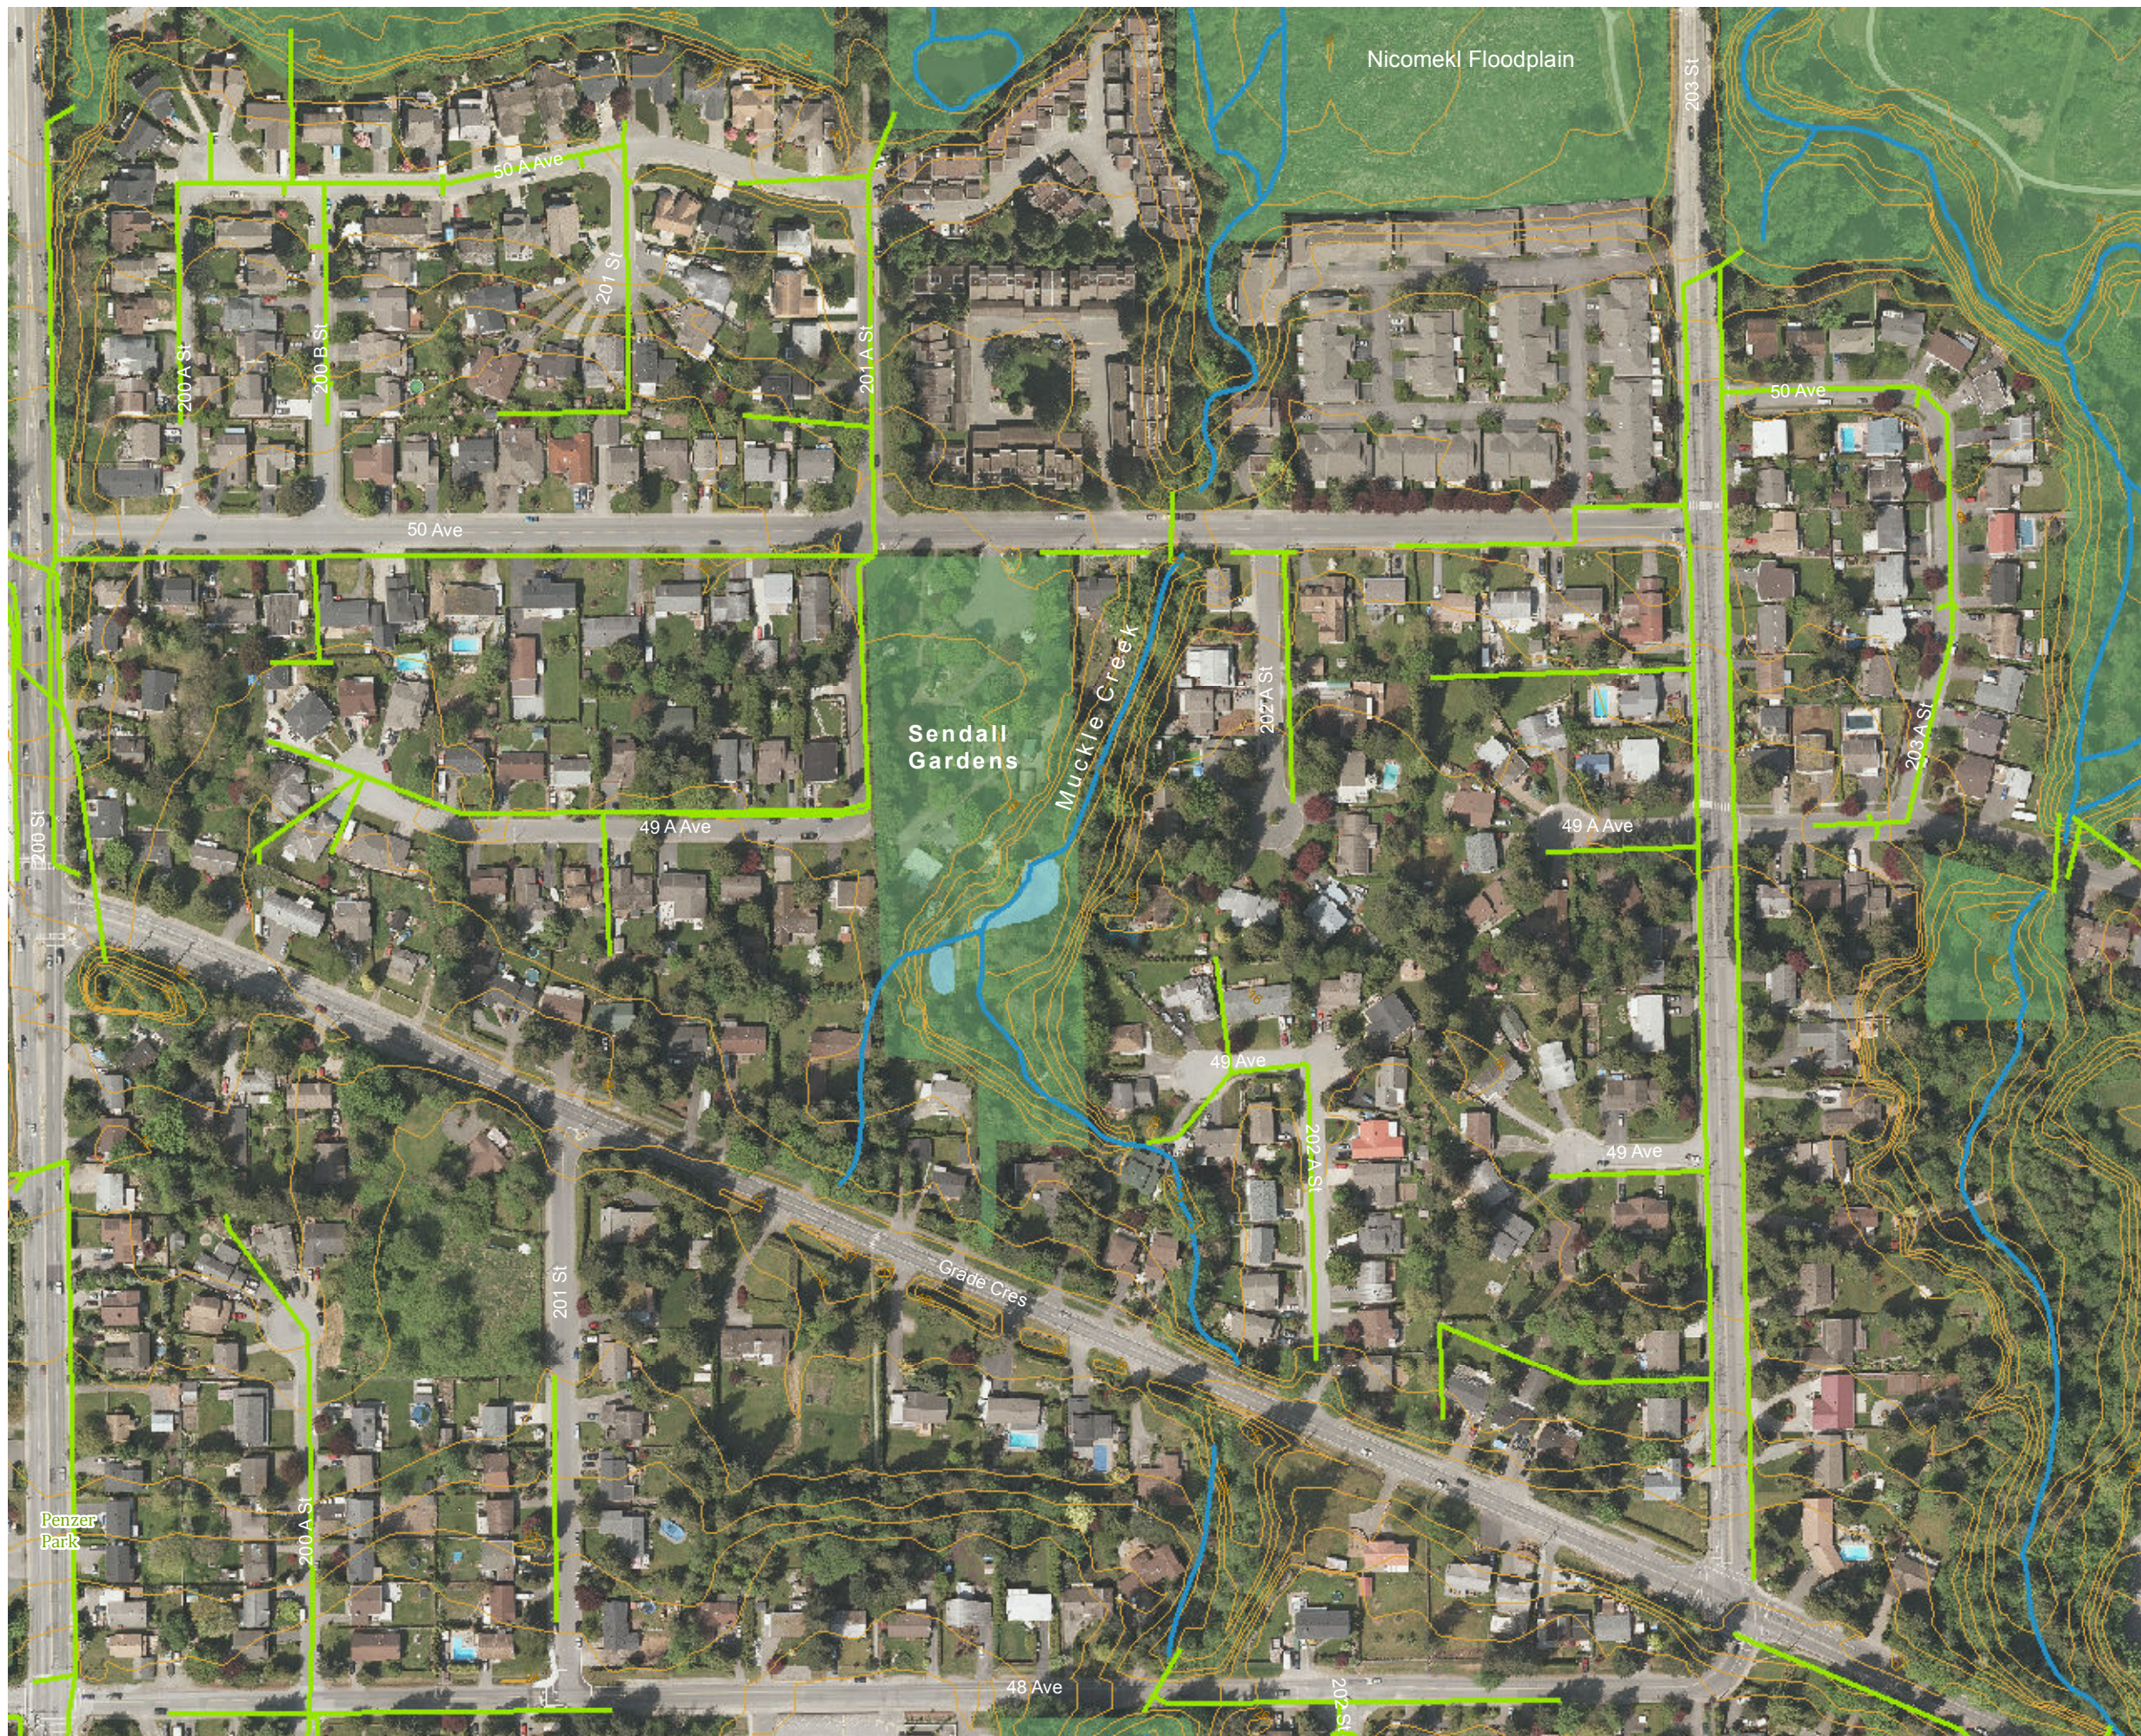
**Sendall Gardens**  
**Existing Drainage Features**

Sendall Gardens includes two small ponds, which are located within the southern portion of the park near the confluence of Muckle Creek and one of its tributaries. The ponds are situated in close proximity to each other (approximately 10 m apart) and are separated by a narrow gravel pathway. The larger (lower) pond is an on-line facility along Muckle Creek, while the smaller (upper) pond is an off-line feature that is hydraulically connected to the creek and tributary by a series of culverts.

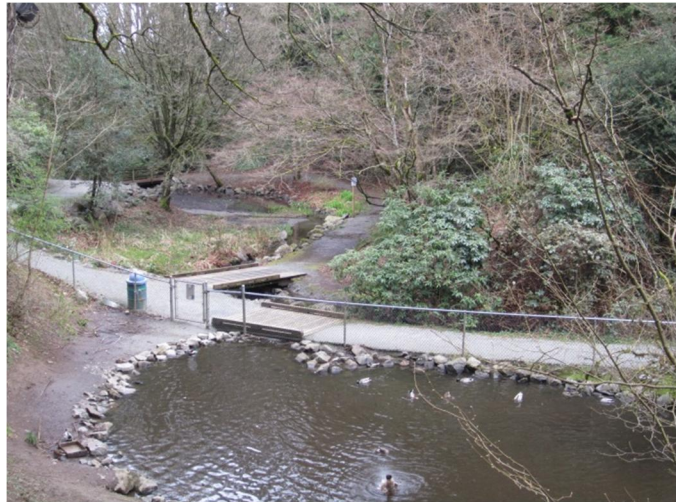
The adjacent photograph (taken facing northeast from the southeast corner of the site), shows the upper and lower ponds in the foreground and background, respectively. Refer to

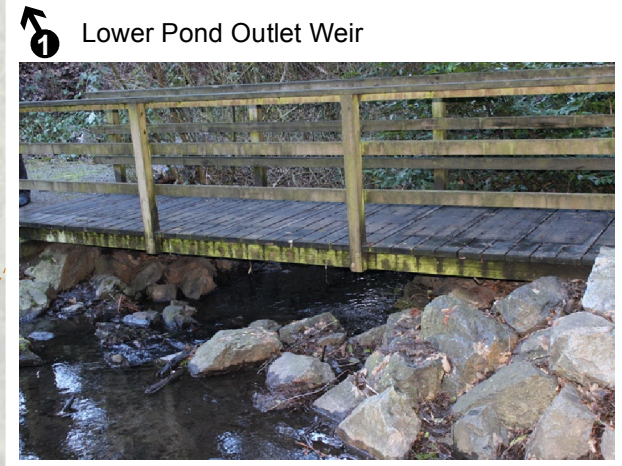
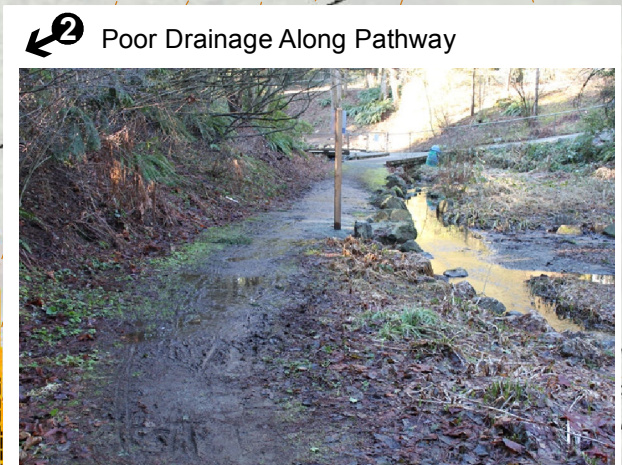
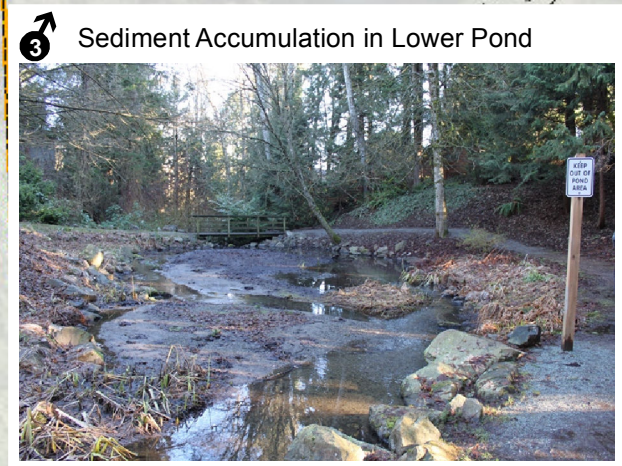
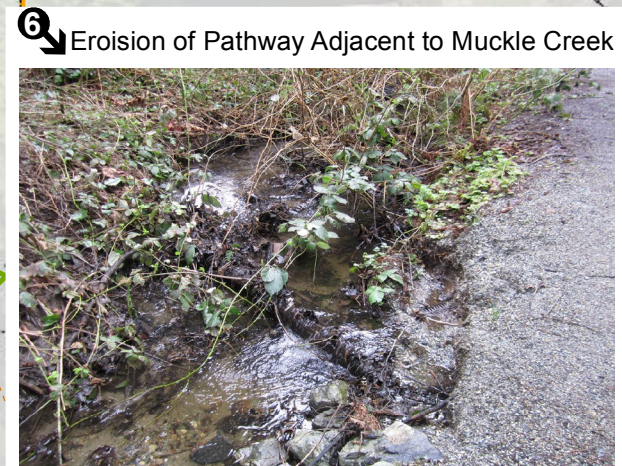
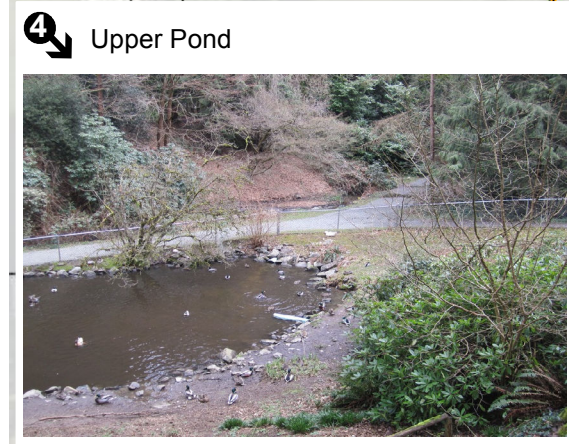
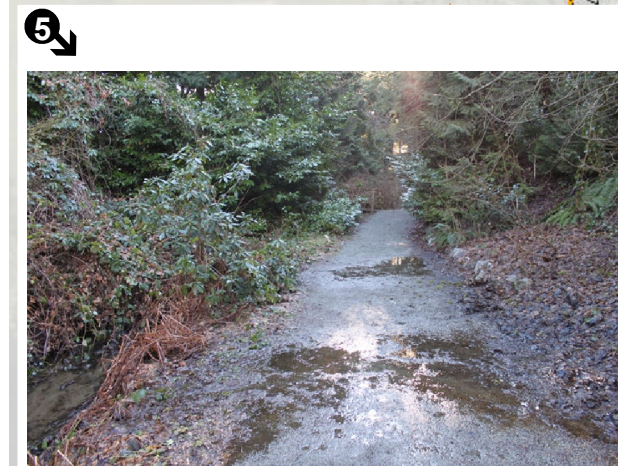
**Sendall Gardens**  
Key Issues Summary  
Figure 20

- i) A significant volume of sediment has accumulated within the lower pond (estimated at approximately 75 m<sup>3</sup>), which has affected its hydraulic performance and aesthetic value, and is considered to be a safety hazard following an incident where park users got stuck in the pond adjacent to the pathway. Further, accumulation of sand and sediment was observed in the Muckle Creek channel upstream of the lower pond for most of its length within the Sendall Gardens property.
- ii) The condition of many of the gravel pathways in the southern portion of the Sendall Gardens Park have deteriorated and require considerable maintenance to address poor drainage and safety concerns. Standing water and saturated ground conditions resulting from groundwater seepage through steep slopes and embankments were observed at multiple locations during field investigations, including much of the

- iii) No safety measures are in place between the lower pond and the adjacent pathway along its southern and eastern perimeter – it is recommended that a barrier (*e.g.*, fencing, landscaping, etc.) should be installed to provide a barrier to prevent park users from accessing the pond area.
- iv) The existing rock weir at the outlet of the lower pond is in poor condition and requires maintenance to remove accumulated debris and reconfigure the rock weir to improve the hydraulic performance of the pond.
- v) Under current conditions, there is a limited circulation of the upper pond, which could result in poor water quality conditions in the water feature, particularly given the anticipated amount of organic materials within the pond (*i.e.*, bird feces, decaying vegetation, etc.).

In addition to the above, it is recommended that fencing (e.g., split-rail) is installed between the lower pond and the pathway along its eastern bank to improve safety for park users. As an alternative, suitable vegetation and/or boulders could be considered.

As noted in Section 2.4, a considerable volume of sediment has accumulated within the lower pond, which has affected its appearance and hydraulic performance. To address the current issue and reduce future maintenance efforts, it is proposed that the sediment is re-graded to form a terraced low-flow channel within the central portion of the pond. The resulting channel configuration would lower the potential for sediment accumulation by maintaining a sufficient flow velocity through the pond.
